State-Licensed Disposal Area at West Valley: 2019 Annual Report

Final Report - March 2020

State-Licensed Disposal Area at West Valley:

New York State Energy Research and Development Authority

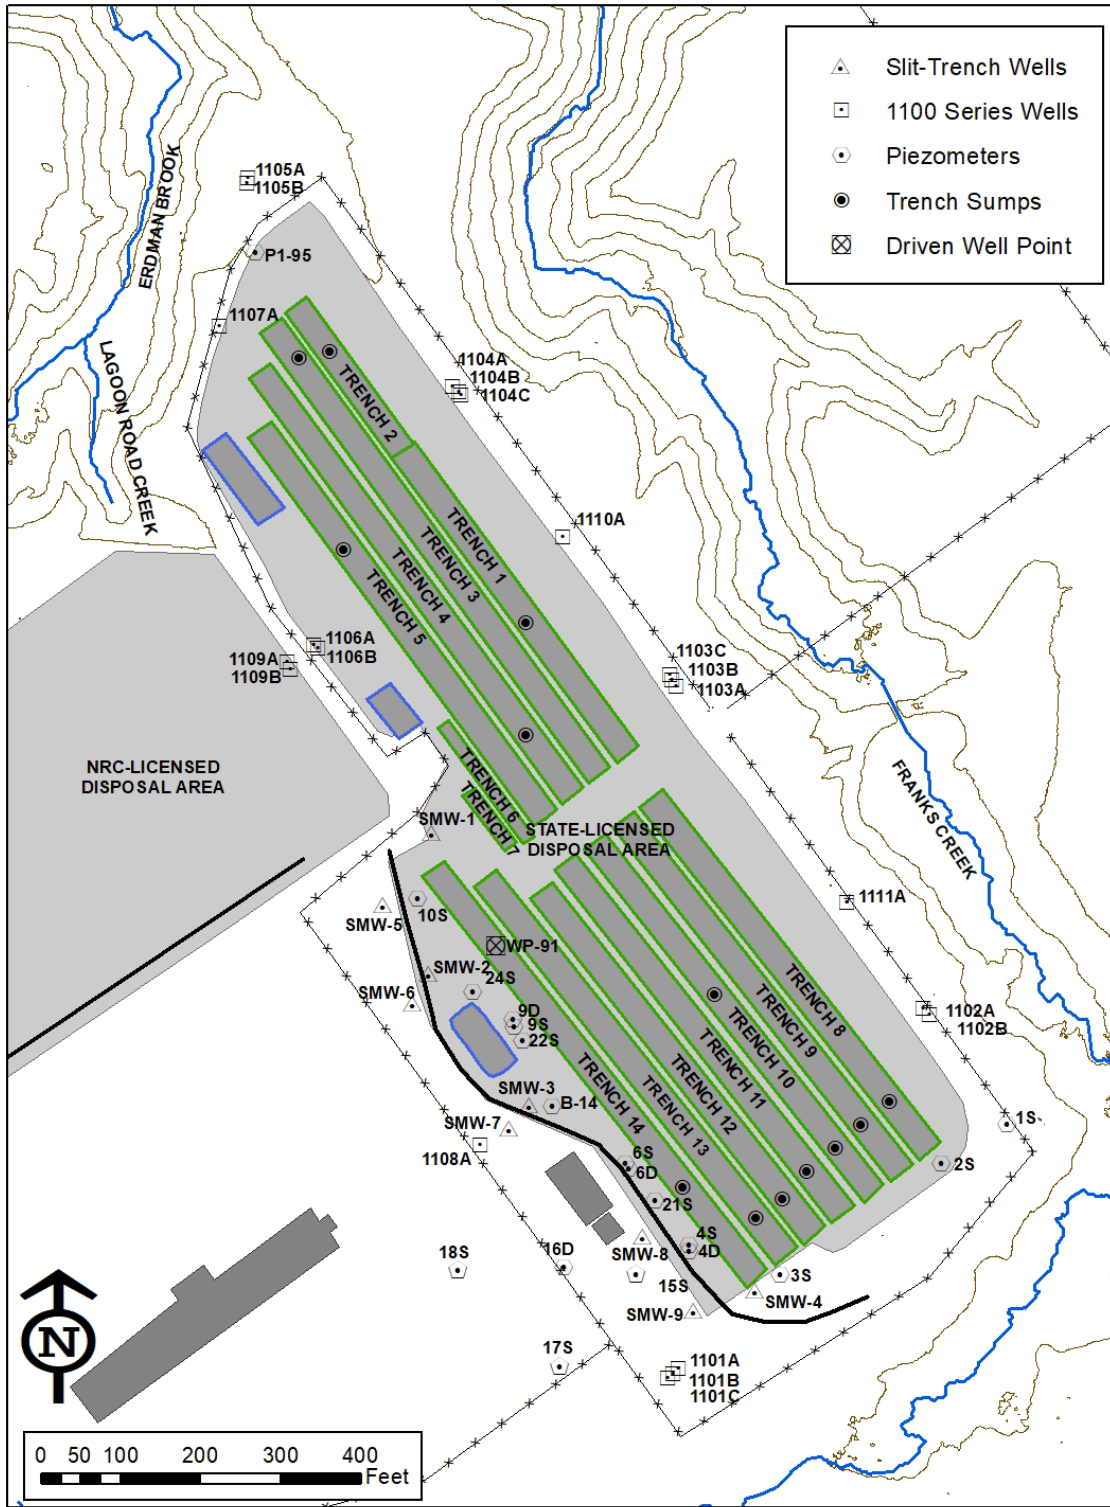
Figure 2-1. Trench Sump and Groundwater Monitoring Locations

Leachate elevation measurements for 2019 were collected quarterly in March, June, September, and December (see Table A-1). Additional monthly leachate elevation measurements were taken in Trenches 13 and 14 (including WP-91) (see Section 2.1.2).

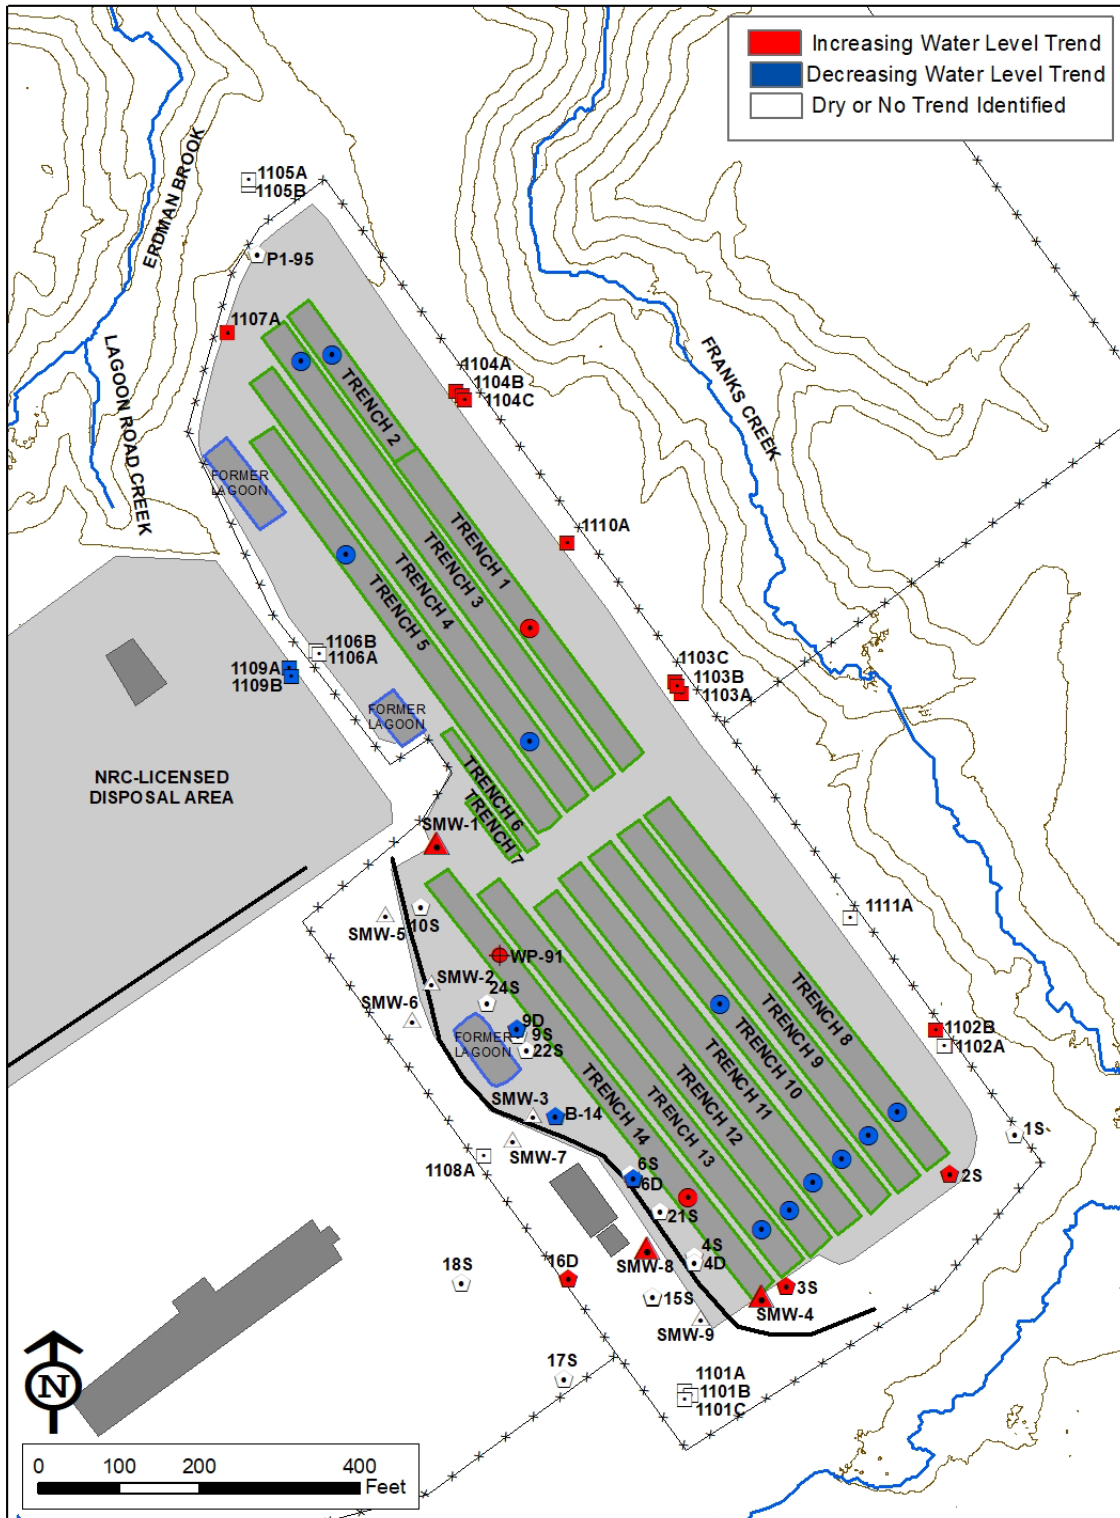
Figure 2-2. SDA Water Elevation Trends

As Figure 2-2 shows, the majority of the wells located within the area covered by the geomembrane and immediately downgradient of the slurry wall are dry or exhibit no trend. Two locations upgradient of the slurry wall show an increasing trend. The distribution of groundwater elevations near the west side of Trench 14, and the decreasing long-term leachate elevation trends in all but two of the SDA trenches, reflect the continued effectiveness of the water infiltration controls system (i.e., subsurface barrier wall and geomembrane cover).

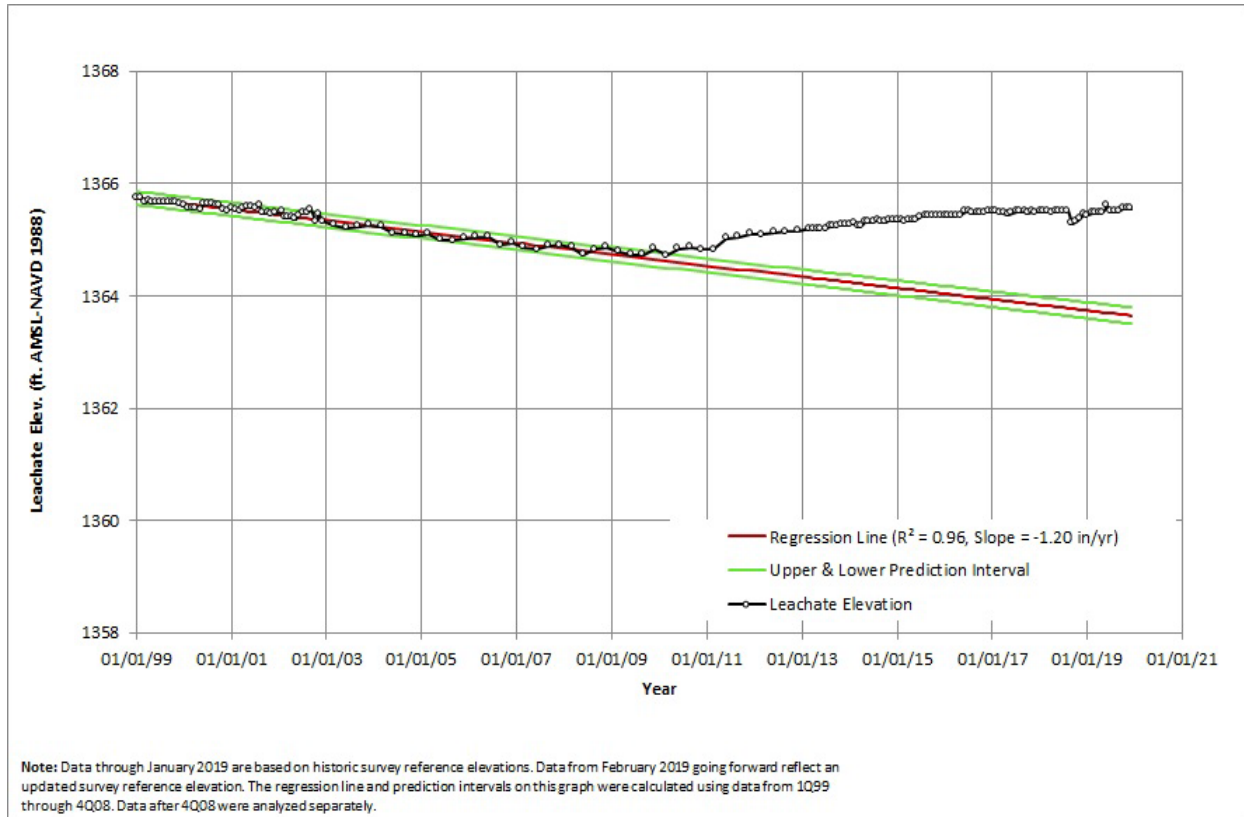
Figure 2-3. Trench 14 Leachate Elevations for the Period 1999 to 2008

The regression line is shown in red, with the 95% prediction interval shown in green.

Following the installation of infiltration controls in the mid-1990s, the Trench 14 leachate elevation followed a consistent and generally predictable decreasing trend (Figures 2-3 and A-14). A noteworthy change in behavior of this trend occurred in approximately 2008 through 2011 when the decreasing trend leveled off, as shown in Figure 2-4.

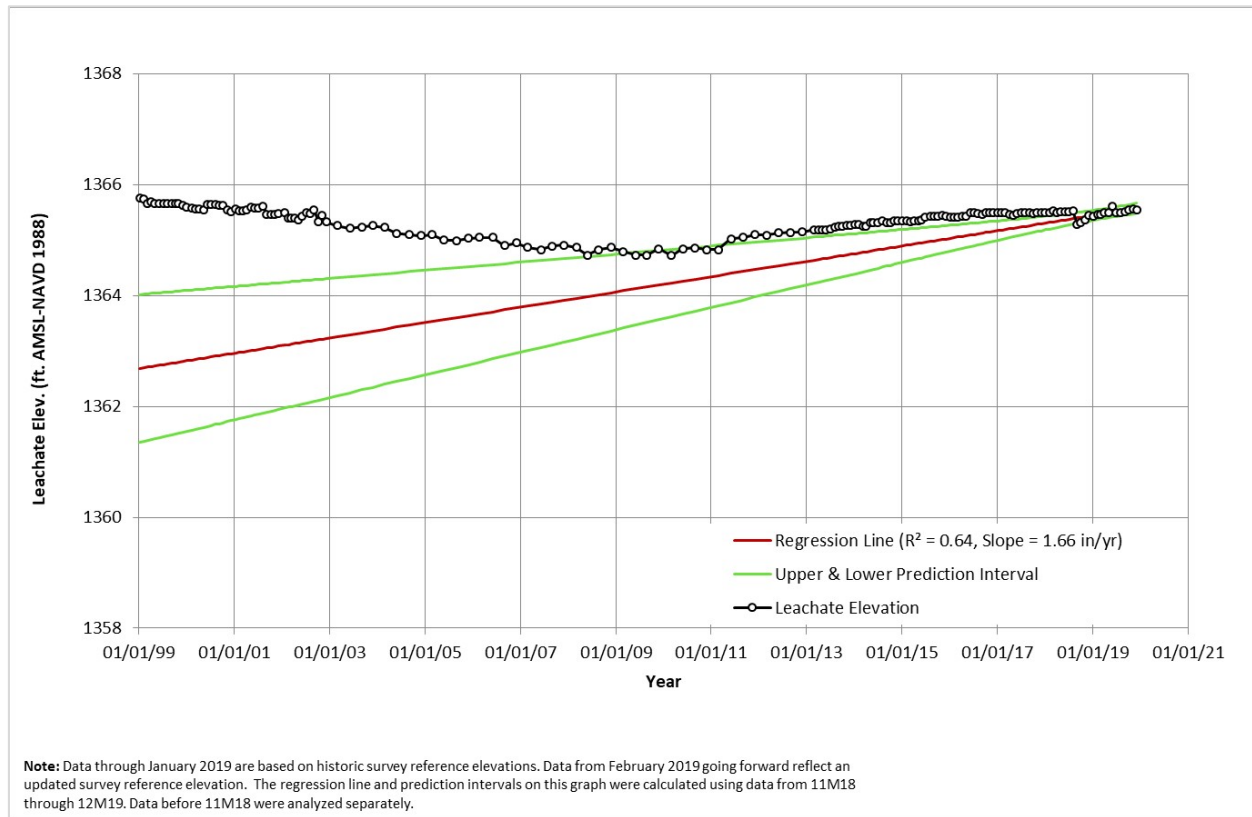
Regression line is shown in red, with the 95 percent prediction interval shown in green.

Small increases and decreases have been observed since 2011; but overall, the Trench 14 leachate elevation continued to increase each year, although none of the increases triggered regulatory reporting requirements.

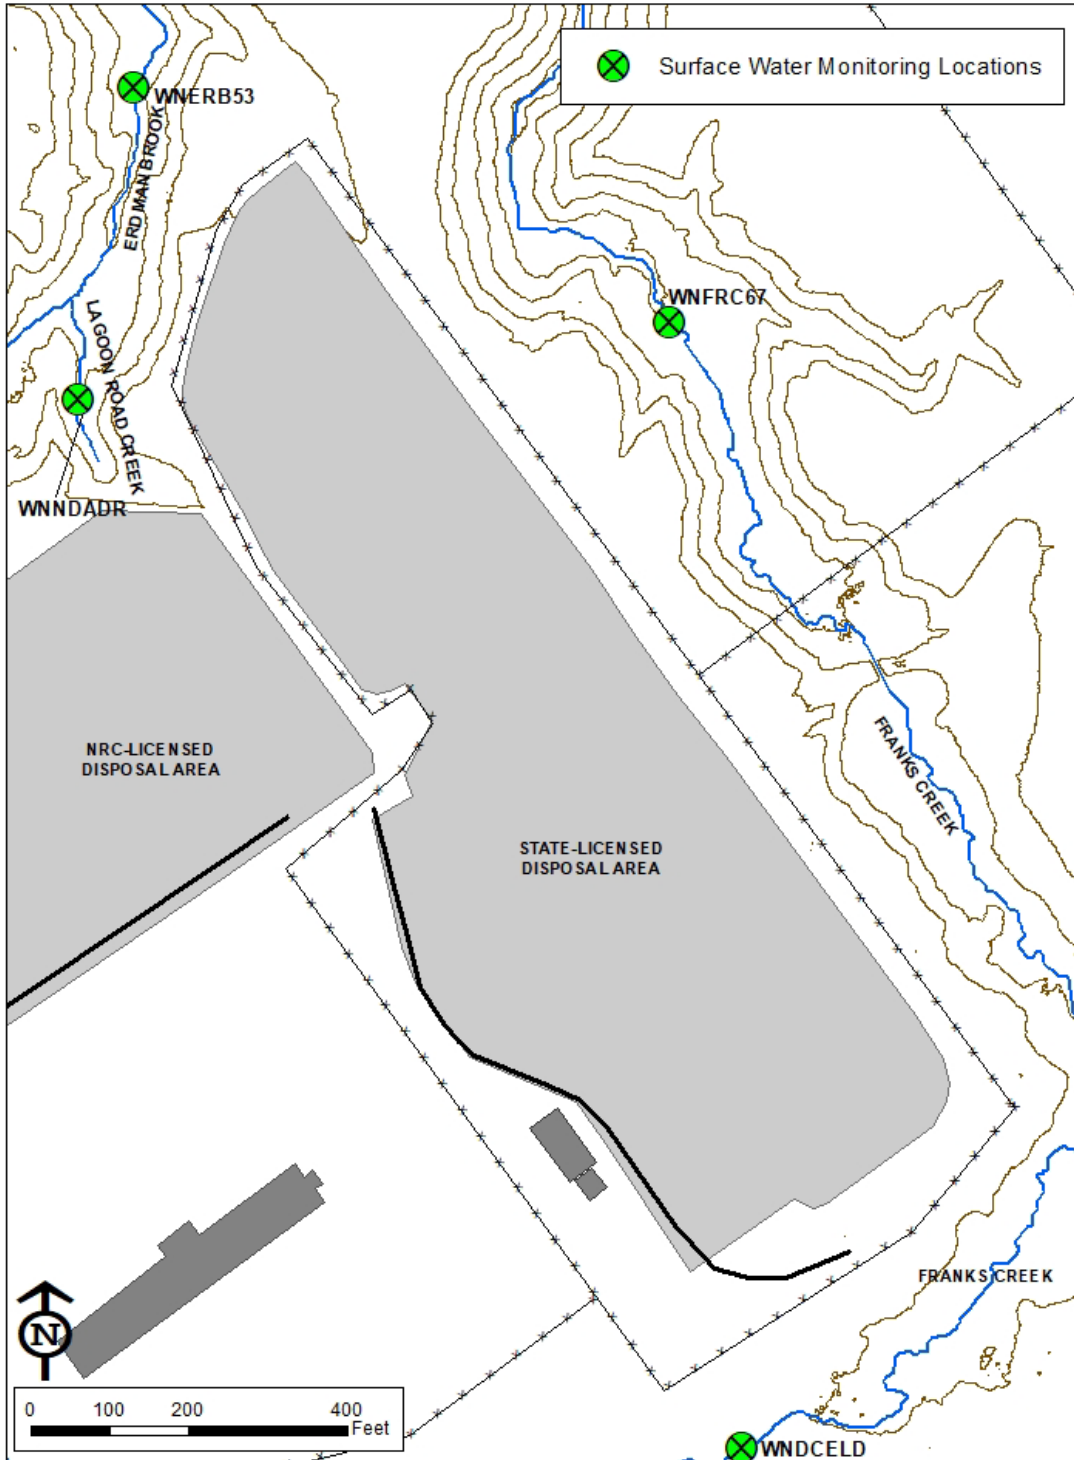
Figure 2-7. Surface Water Monitoring Locations (WNDCELD, WNFRC67, WNDADR, and WNERB53)

The 2019 gross alpha results at three of the four surface water sampling locations (WNDCELD, WNFRC67, and WNERB53) were statistically indistinguishable from background. Gross alpha at sampling location WNDADR for the first quarter of 2019 was statistically different than background, with high residual dissolved solids noted in the sample causing the MDC to exceed the program detection limit. All other WNDADR gross alpha results were consistent with historical data. For all locations except WNDADR, these results are consistent with previous annual statistical assessments. All results, except as noted above for first quarter 2019 WNDADR, were below the 6 NYCRR 703.5 – Table 1 Water Quality Standards for Surface Water and Groundwater (6 NYCRR 703.5¹⁰) (1.5E+01 pCi/L), which is used as a comparative value for gross alpha.

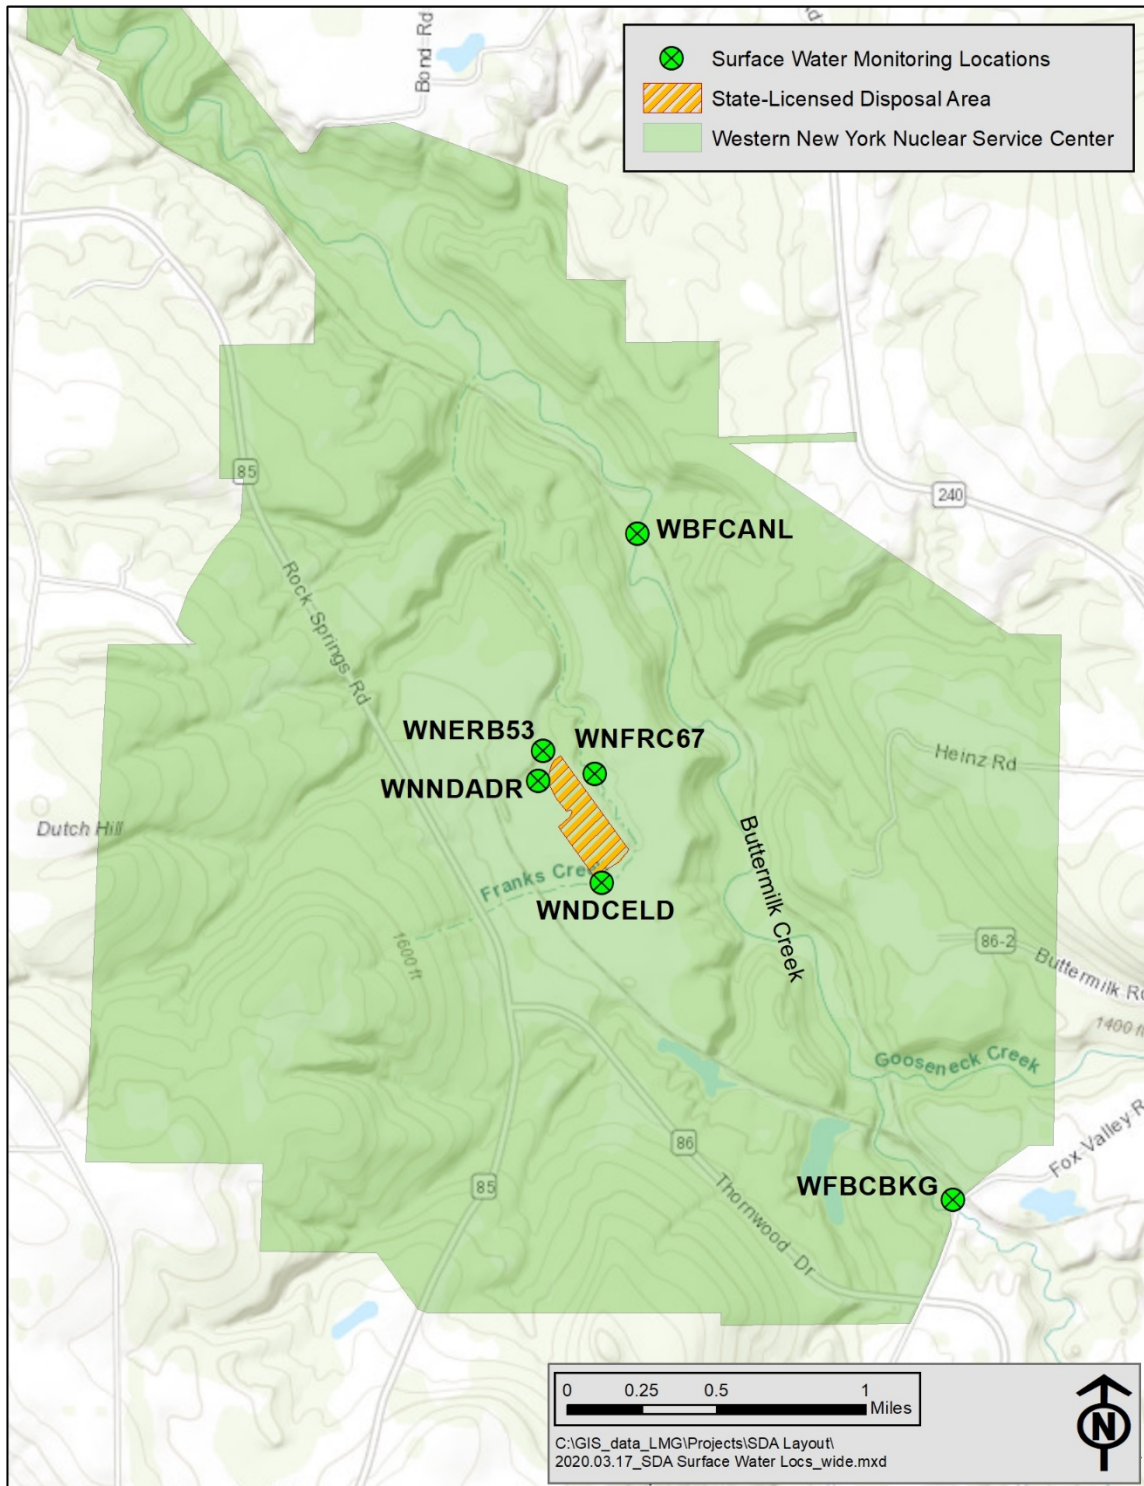
Figure 2-8. Surface Water Monitoring Locations (WFBCBKG and WFBCANL)

Figure 2-8 shows WFBCBKG, located upstream of the WNYNSC in Buttermilk Creek, which monitors background surface water conditions, and WFBCANL, also located in Buttermilk Creek, which monitors Buttermilk Creek just downstream of where the Kent Recessional unit groundwater is discharged to Buttermilk Creek via groundwater seeps.

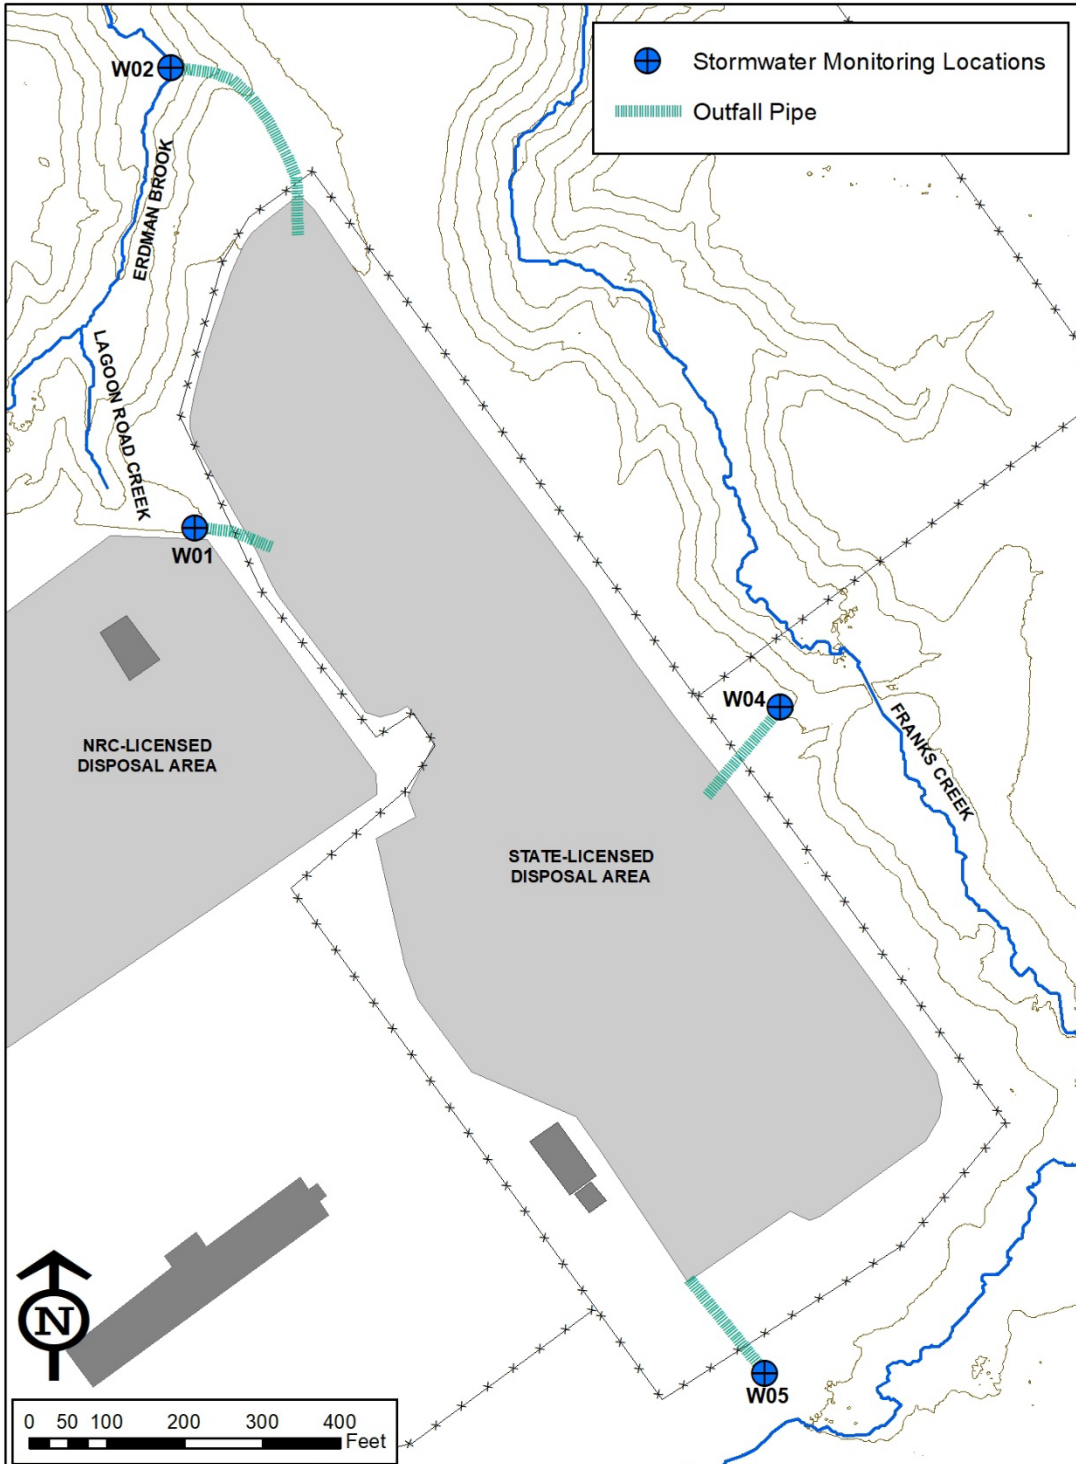
Figure 2-11. Stormwater Monitoring Locations

As required by the SDA State Pollution Discharge Elimination System (SPDES) Permit No. NY-026971, semiannual sampling is conducted at one of the four designated SDA stormwater outfalls (as shown in Figure 2-11). During 2019, semiannual stormwater samples were collected from Outfall W01 during qualifying storm events on May 28 and October 16.

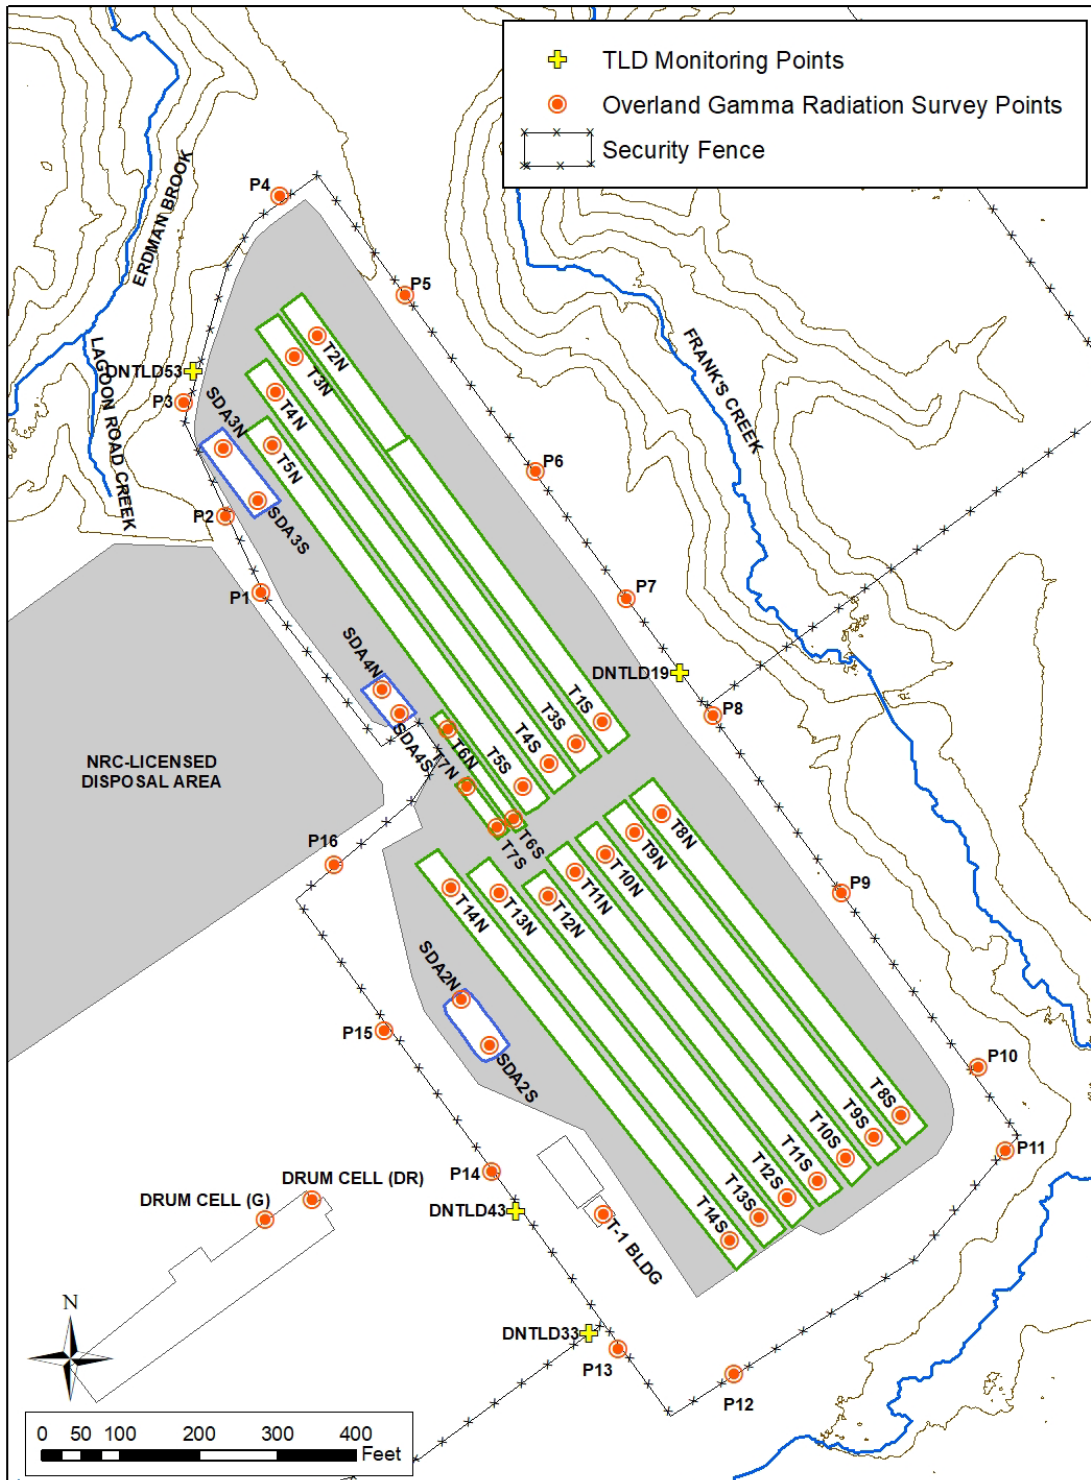
Figure 2-12. Gamma Radiation Monitoring Locations

- Two survey points (DC-[G] and DC-dr) at the WVDP Drum Cell, located west of the SDA, provide information on the radiation levels near the Drum Cell. Historically, waste in the Drum Cell created elevated radiation levels at the nearby SDA monitoring points. Radiation levels have fallen since the waste was removed from the Drum Cell in 2007.

At each fixed survey point, radiation levels are measured at one meter and one centimeter (cm) above the ground, floor, or building surface.

Gamma radiation levels observed during both semiannual surveys were consistent with historical data.

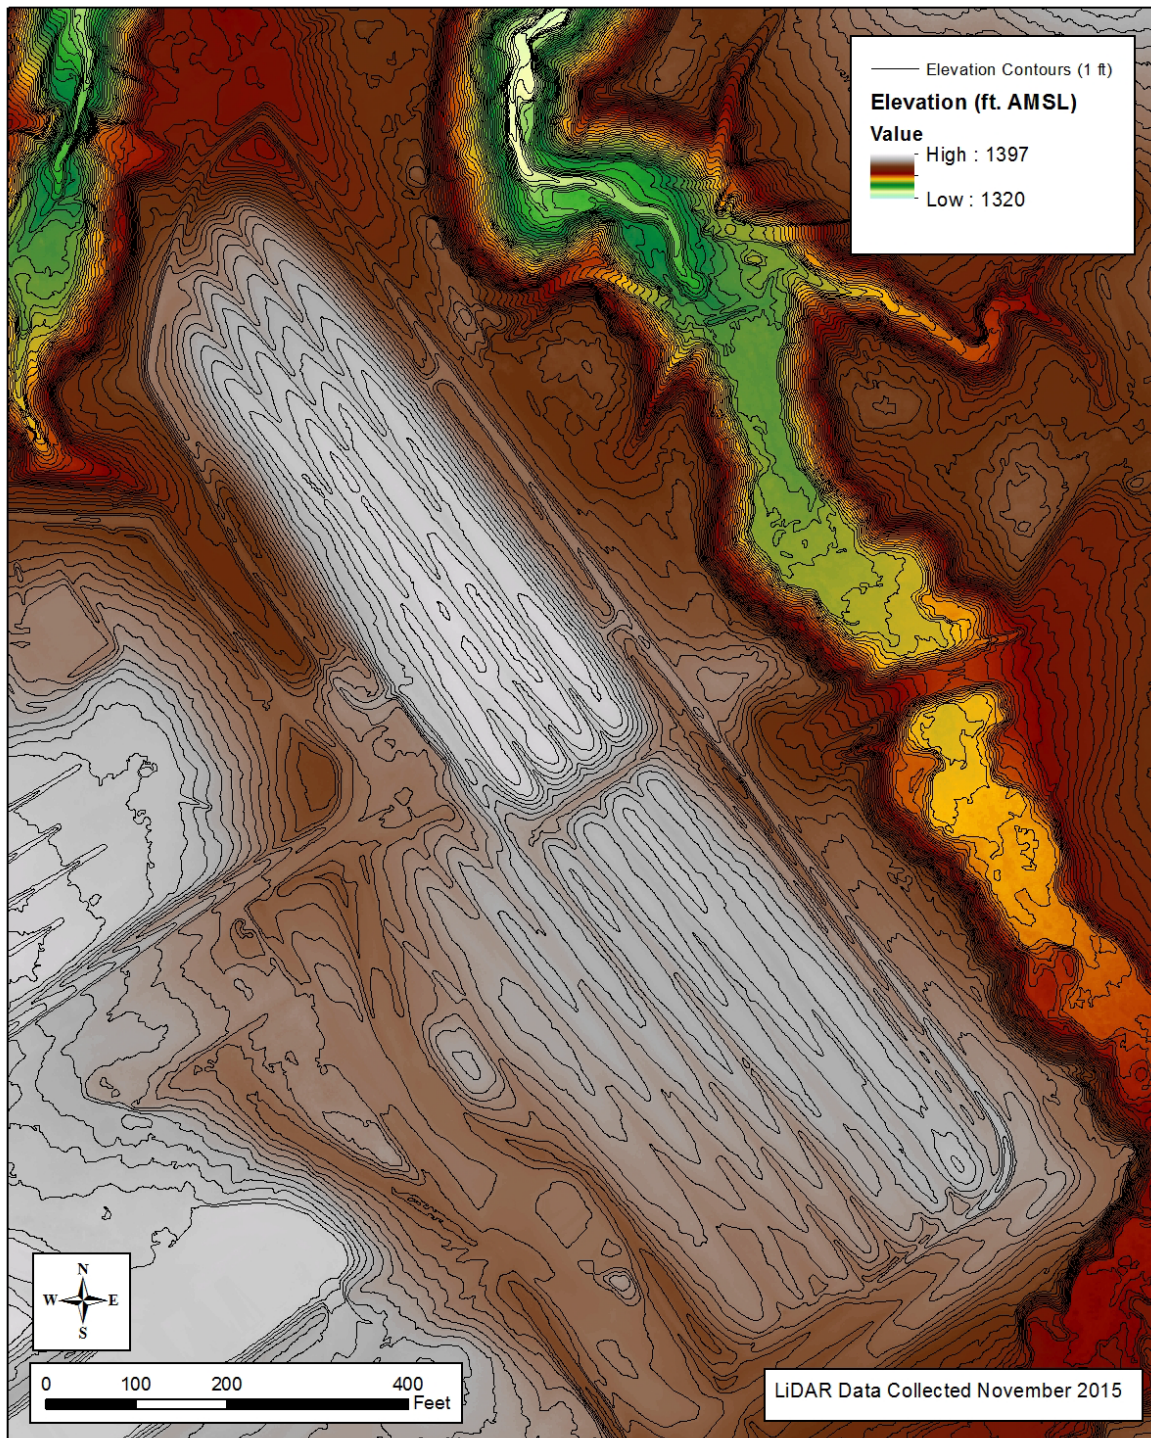
Figure 3-1. LiDAR-Derived Topographic Map of the SDA and the Surrounding Areas

and gullies in the watershed, as would be expected. There was no evidence of erosion in areas adjacent to the SDA. There were some topographic changes at points along Erdman Brook and Franks Creek, which were directly attributable to the construction of erosion controls at these locations. NYSERDA plans to update the LiDAR survey with new data collection in November 2020.

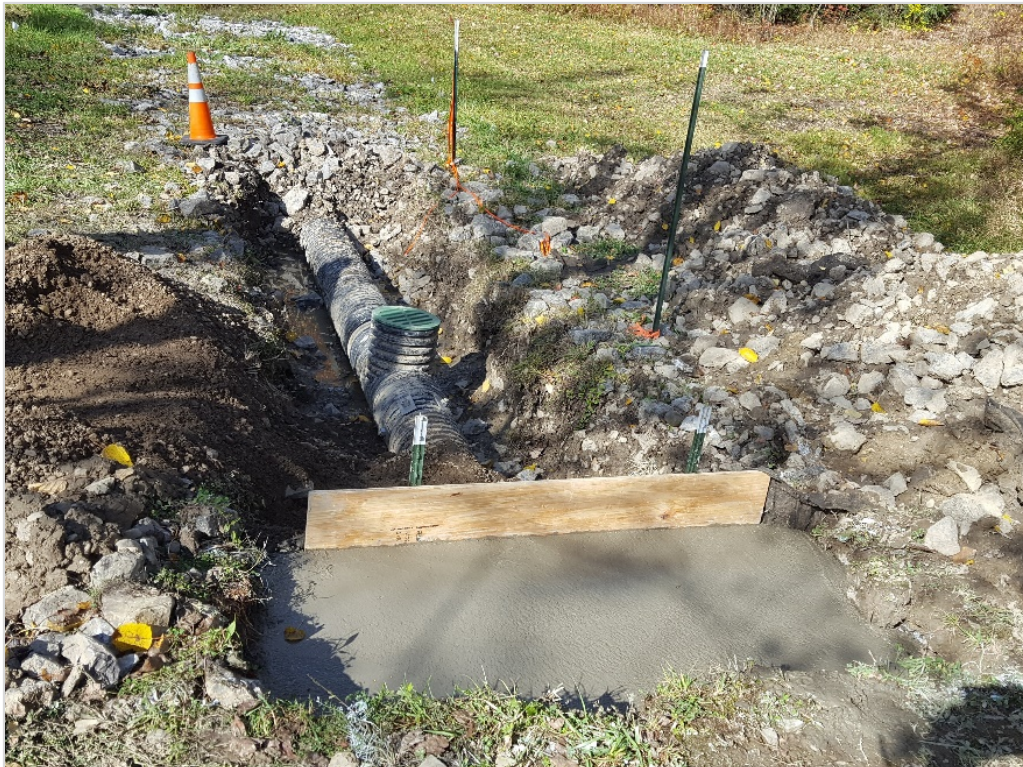
Figure 4-1. W02 catch basin pipe discharge modifications

- removal of a beaver and impoundment located within the Franks creek corridor east of the SDA
- initiation of nuisance wildlife relocating efforts
- completion of focused topographic surveys of trench cap subsidence
- repair of the SDA overhead lights in the Frac Tank Building
- modification of the stormwater catch basin discharge pipes (see Figure 4-1)
- repair of the SDA vestibule handrail

As noted above, stabilization repairs were completed for outfall locations WO1, WO2, and WO4 in October 2019. These repairs consisted of pinning and grouting the outlet pipe of the catchment basins to limit movement of the pipes from the basins. Monitoring and inspection of these repairs is ongoing.

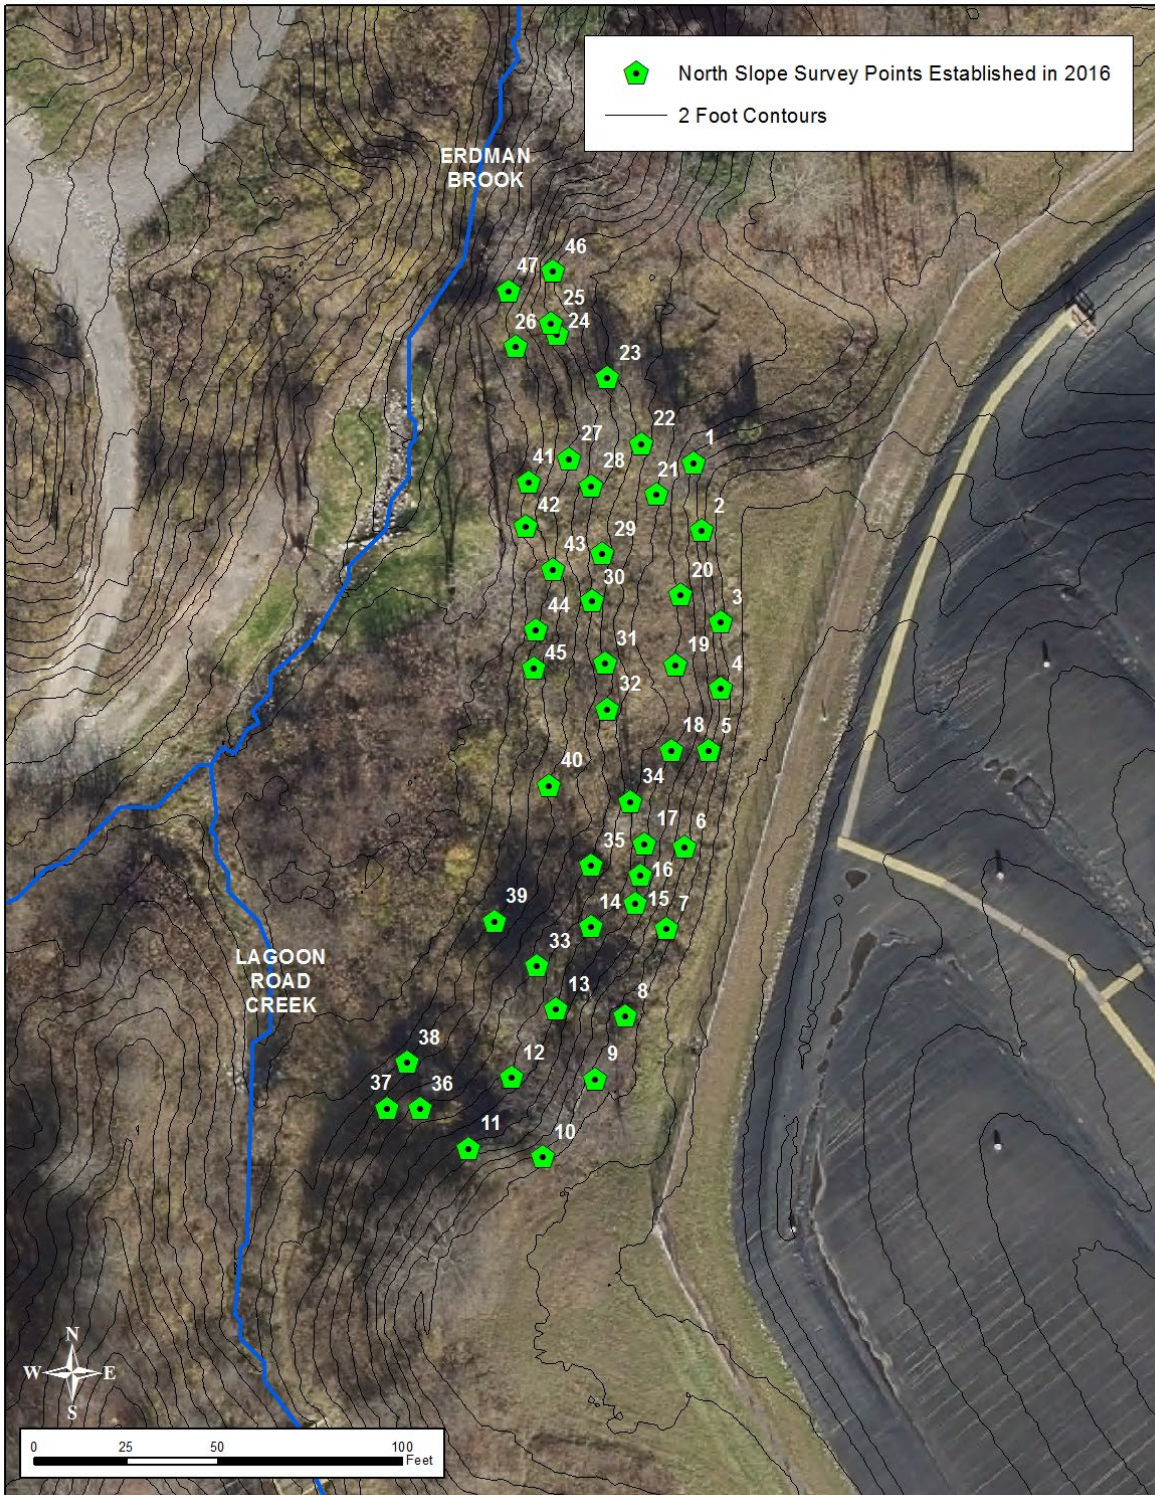
Figure 4-2. North Slope Ground Surface Elevation Survey Points

There were indications in the dataset of nonreportable soil movement, primarily in a lateral northwest direction. NYSERDA conducted a field reconnaissance of the area and found a number of surficial cracks within the North Slope, which were predominantly in the center section. NYSERDA made a courtesy notification to DEC, and engaged our engineering contractor to perform a thorough investigation and resurvey of the North Slope. NYSERDA will continue to keep DEC informed of any new developments on this issue.

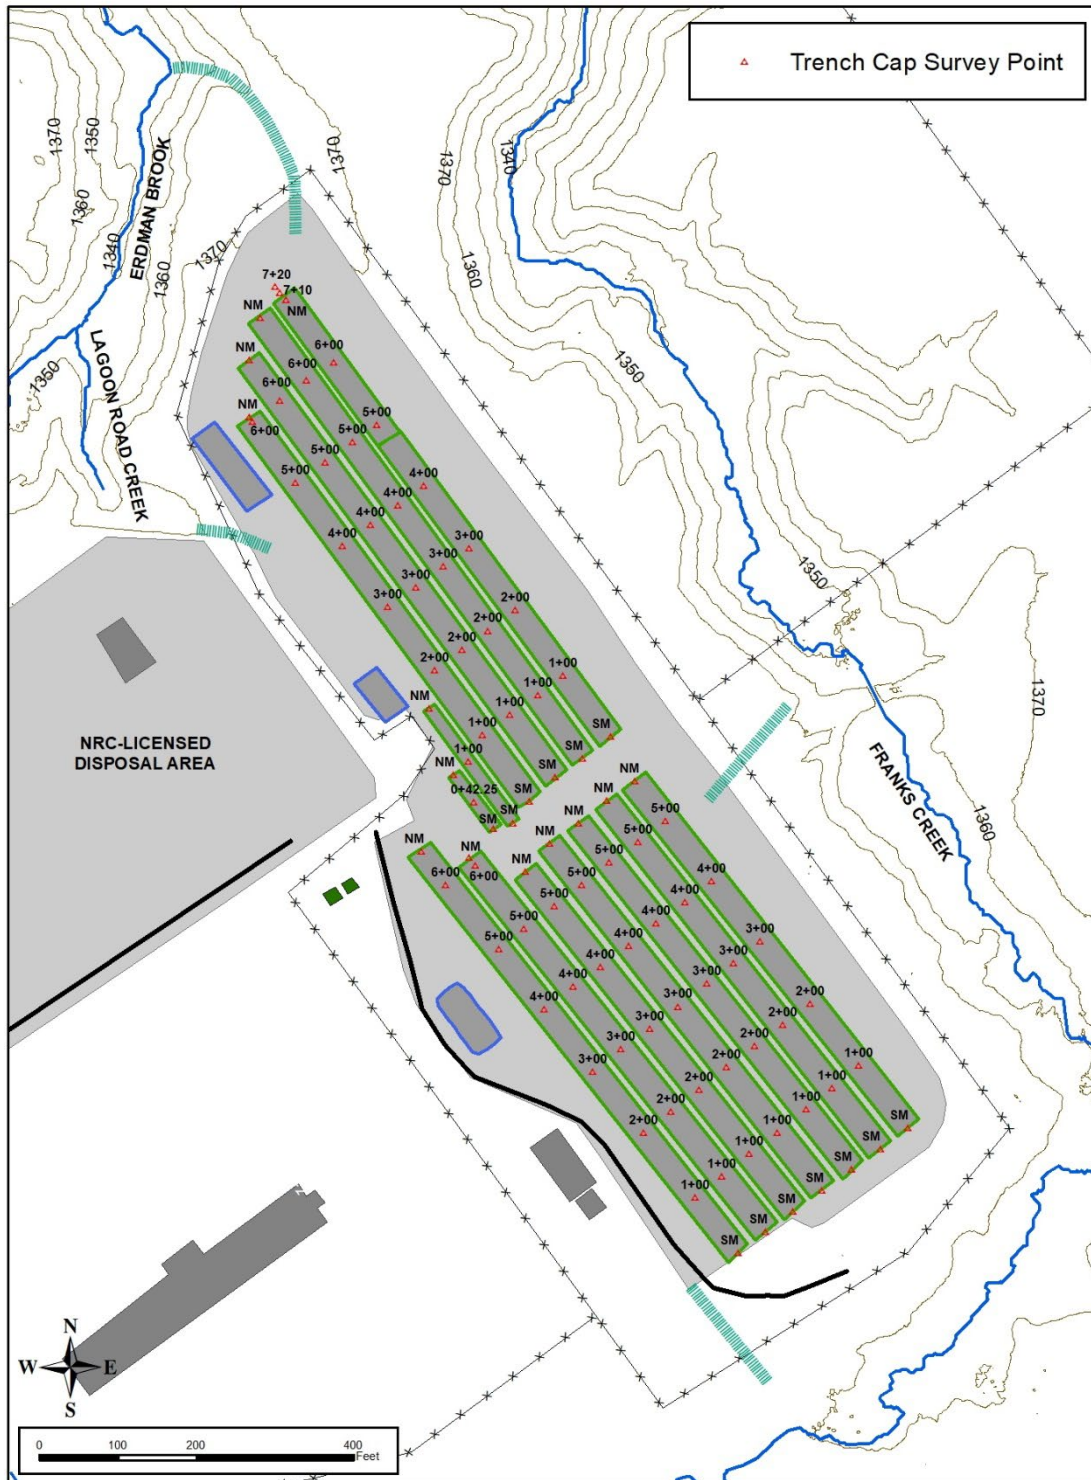
Figure 4-3. Trench Cap Ground Surface Elevation Survey Points

Areas of settlement were observed in 2013 on the southernmost 100-foot sections of Trenches 8 and 13 as well as the northern area of Trench 14. Since 2014, NYSERDA has conducted a focused topographic survey in each of the areas identified above using a 10-foot grid pattern to monitor the rate of subsidence. To date, there has been less than one inch of subsidence per year.

NYSERDA continues to monitor the area on Trenches 13 and 14 with focused topographic surveys in areas observed to be settling or subsiding. In addition to the focused topographic surveys, periodic visual inspections of the trench caps will be performed to provide a more immediate identification of cap subsidence. NYSERDA is evaluating mitigation alternatives for the subsidence on Trenches 13 and 14. NYSERDA will continue to monitor all locations where subsidence has been identified in accordance with our plans and procedures, and will report subsidence to DEC as identified in the plans and procedures.
